# **FY22/23 Maintenance and Monitoring**

**AD98-3, Malibu Road**

**City of Malibu, California**

**Subject: Annual Monitoring and Maintenance Report FY22/23, City of Malibu Assessment District 98-3, Malibu Road, Malibu, CA**

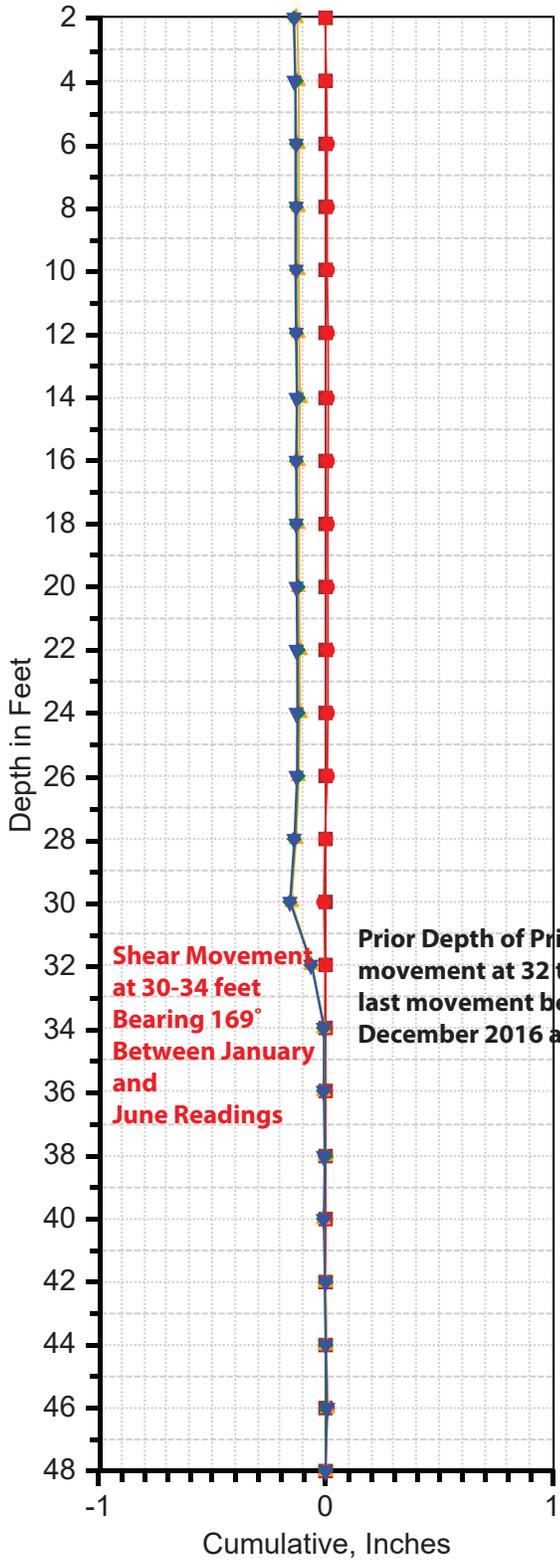
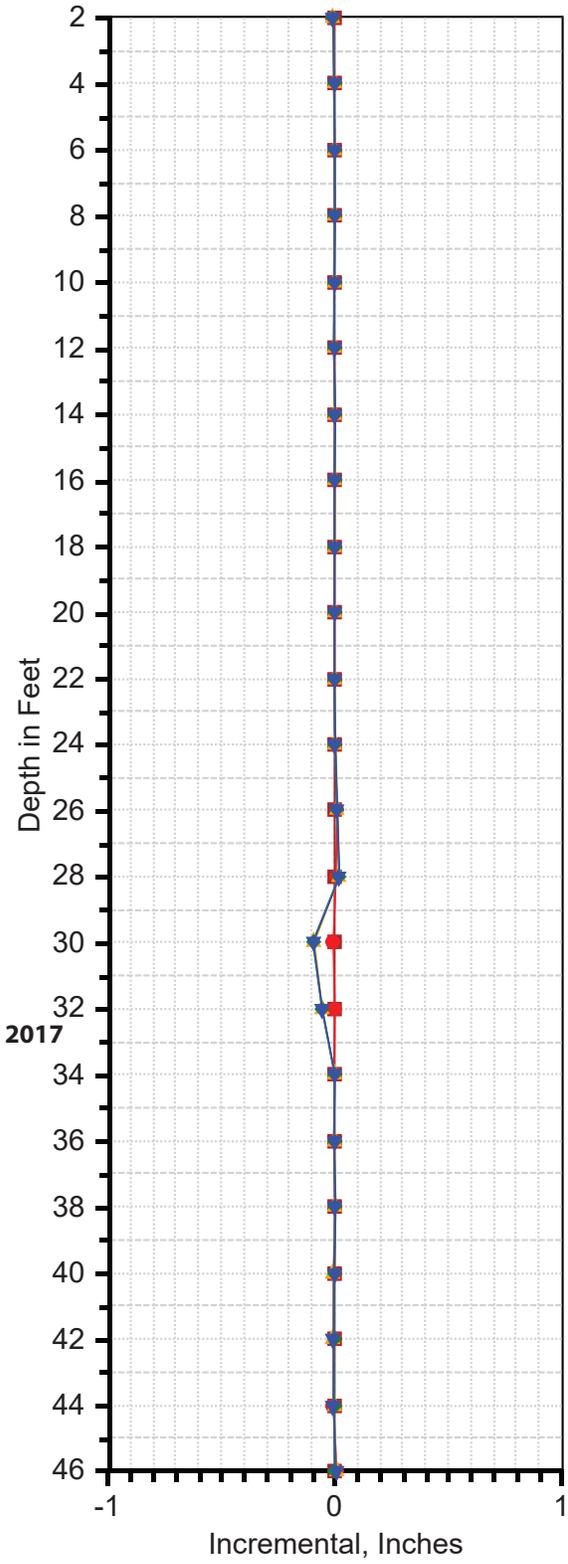
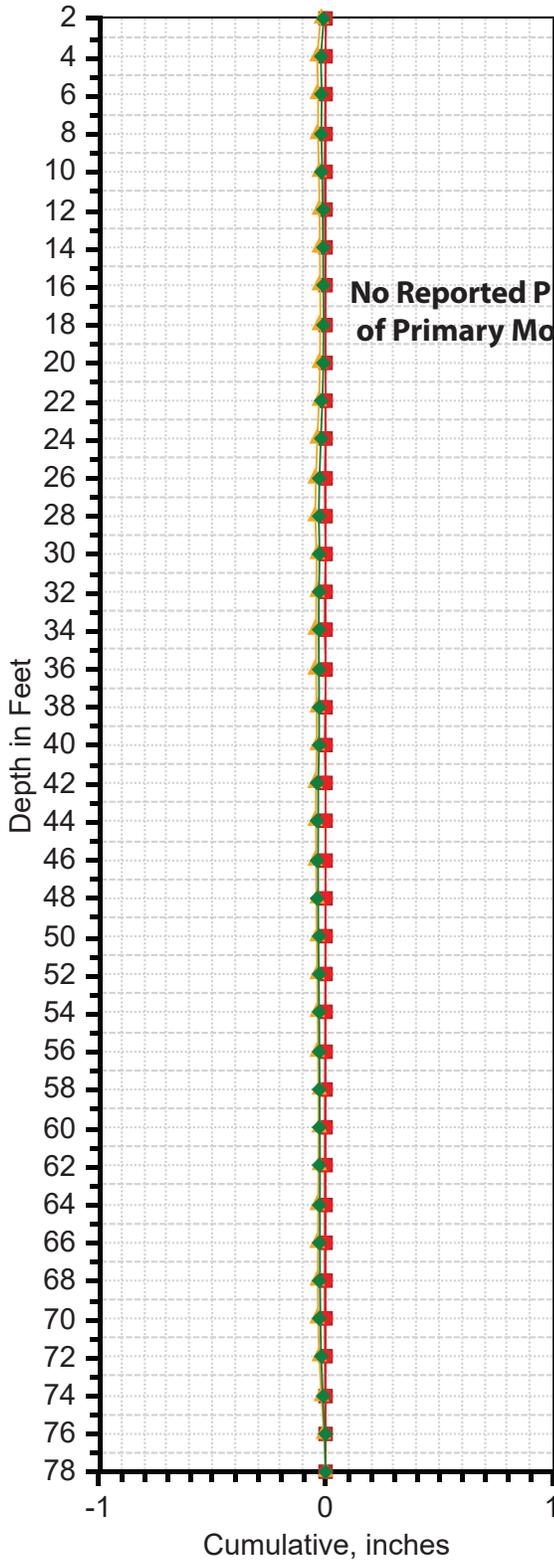
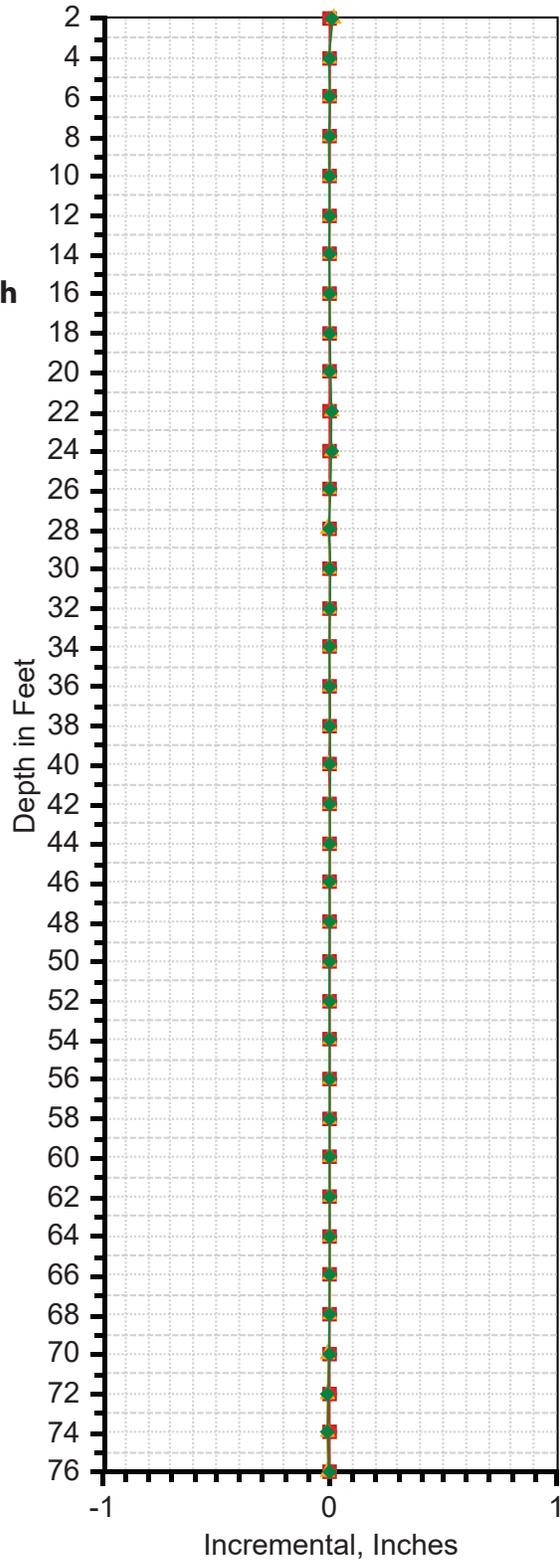
Plot of Slope Inclinometer  <b>SI-4A</b>	Plot Type: Cumulative and Incremental		Plot Direction: A-Direction	
	Depth of Survey (ft): 48		Baseline Date: 8/06/2021	
	Install Date: 8/2012	Installed Depth (ft): 50	Interpreted Movement Since Baseline (in): 0.28	Interpreted Movement Monitoring Year (in): 0.28

<b>Plot of Slope Inclinometer</b>  <b>SI-4A</b>	Plot Type: Cumulative and Incremental		Plot Direction: B-Direction
	Depth of Survey (ft): 48	Baseline Date: 8/6/2021	Corrections: None
	Install Date: 8/2012	Installed Depth (ft): 50	Interpreted Movement Since Baseline (in): 0.28
			Interpreted Movement Monitoring Year (in): 0.28

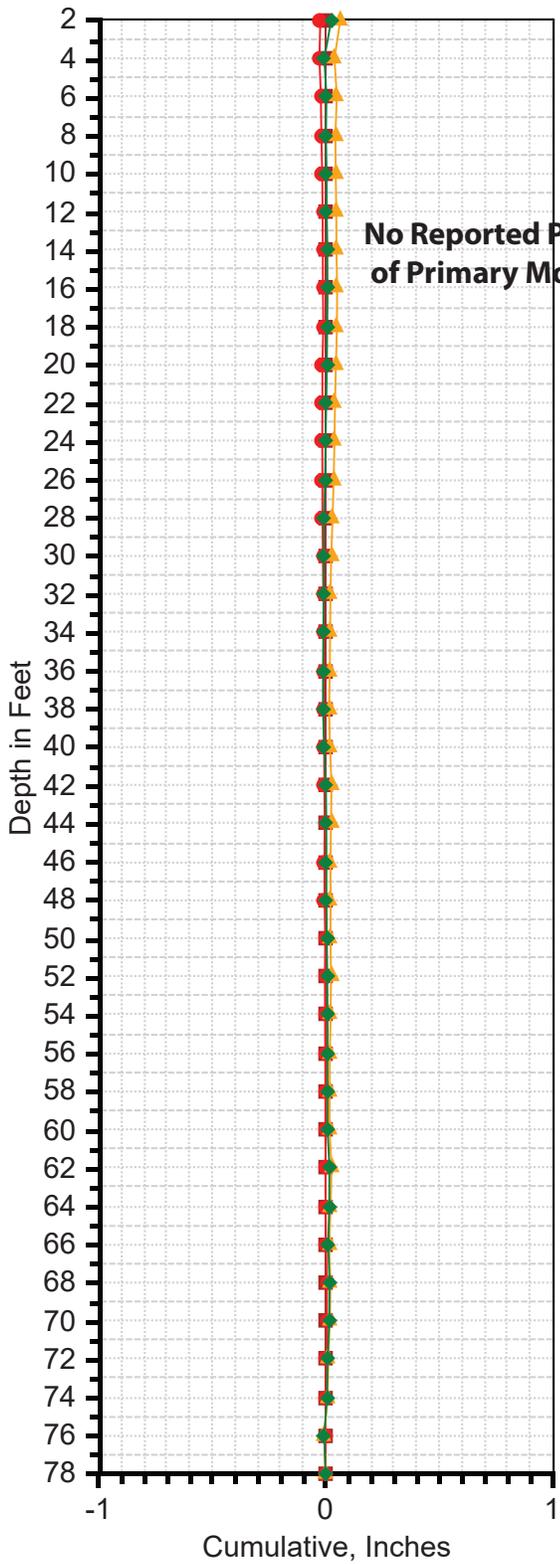
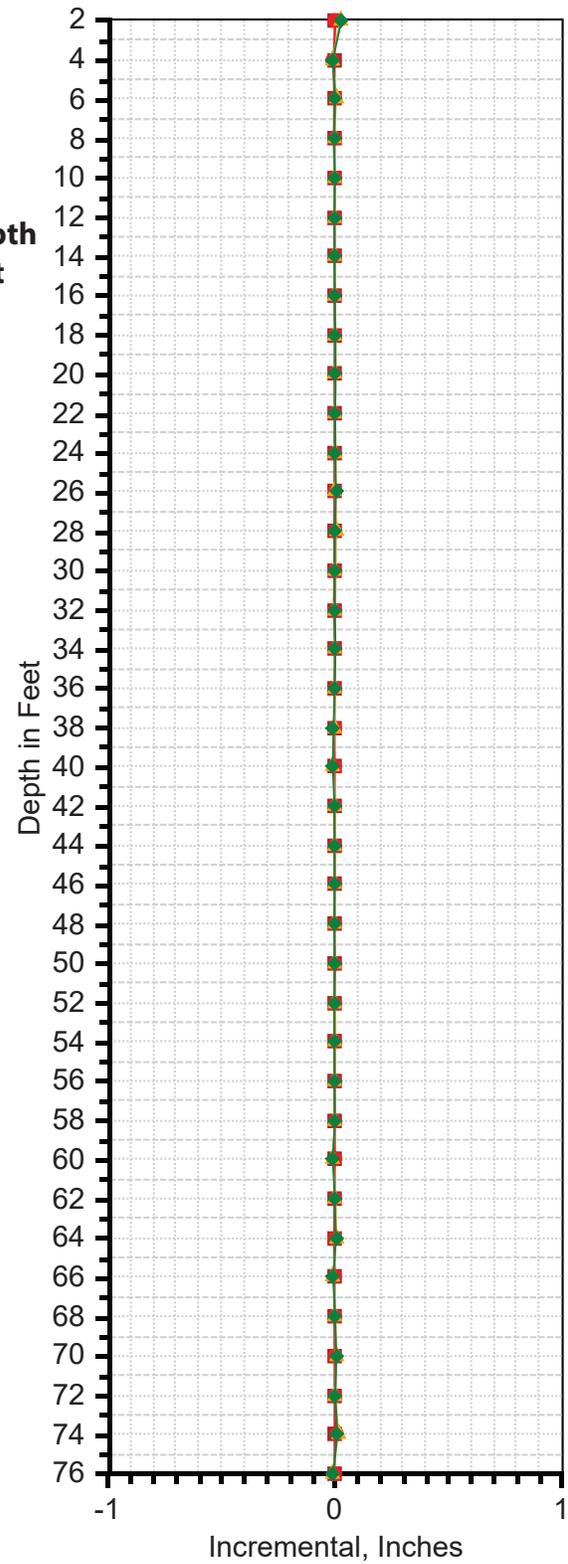
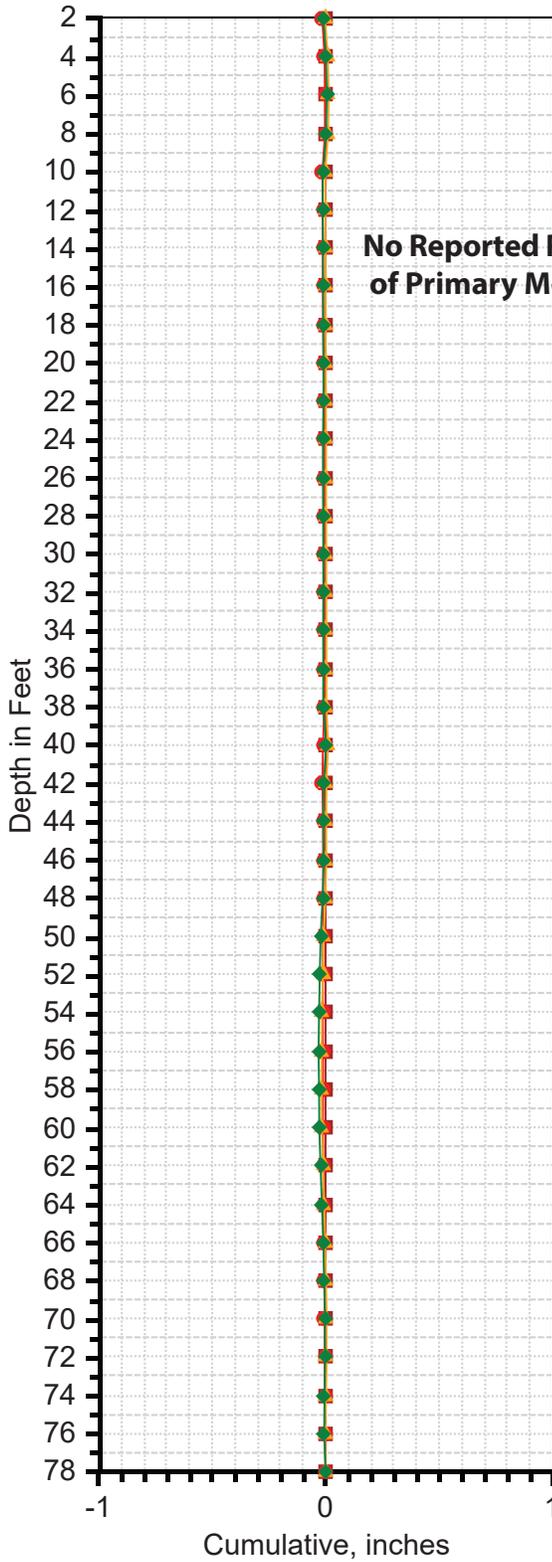
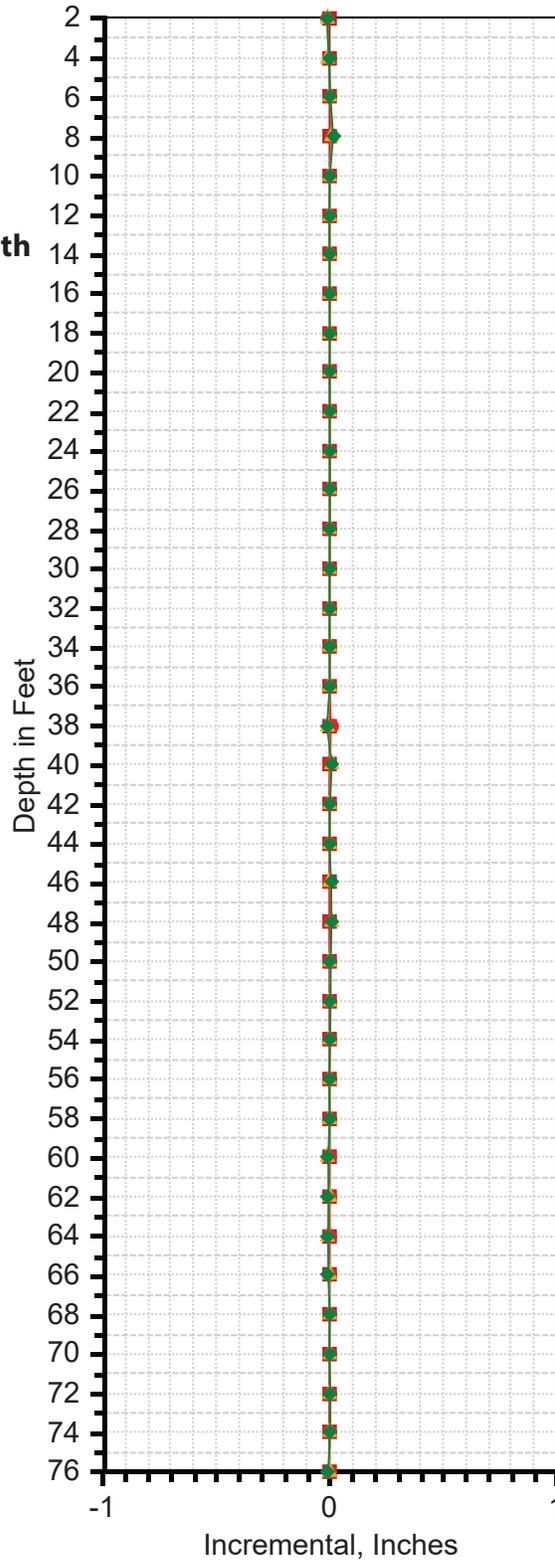
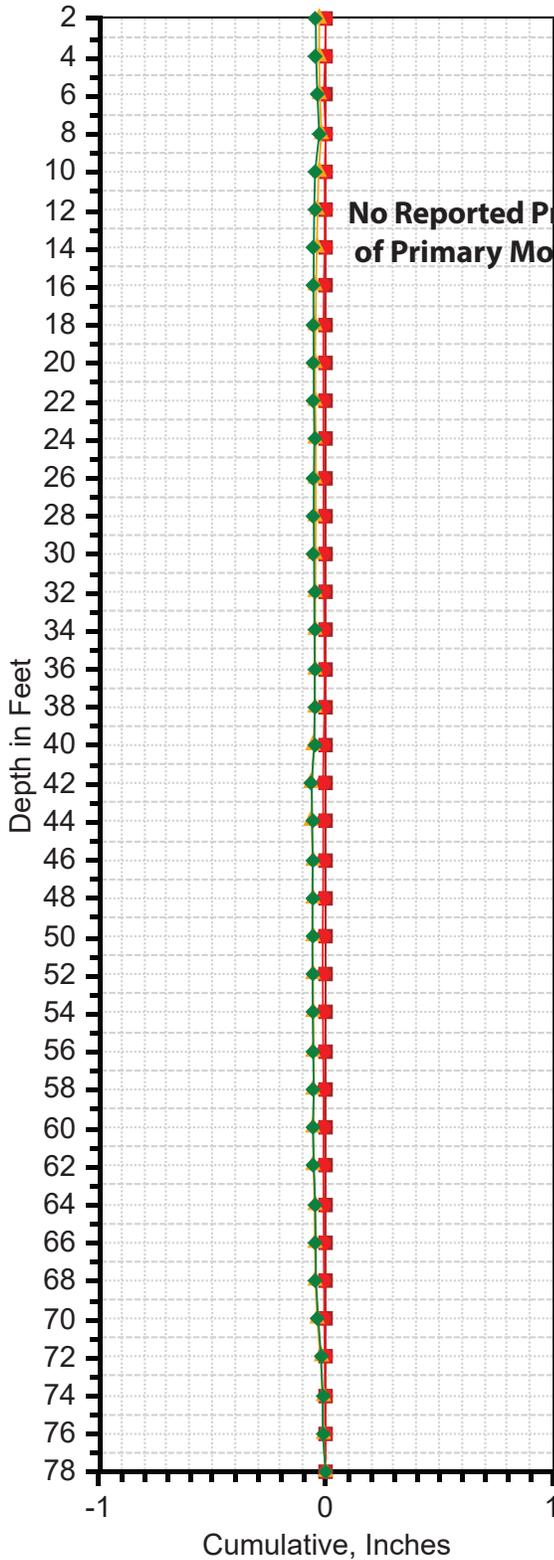
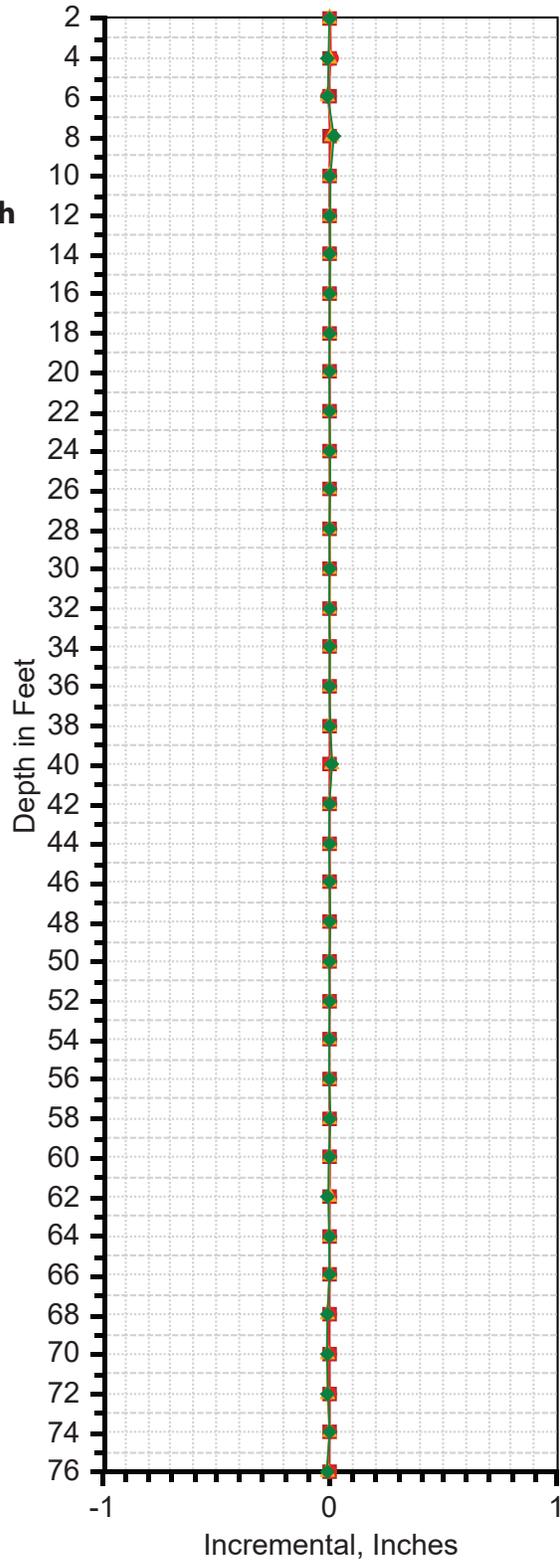
Plot of Slope Inclinometer  <b>SI-5</b>	Plot Type: Cumulative and Incremental		Plot Direction: B-Direction
	Depth of Survey (ft): 78	Baseline Date: 5/3/2021	Corrections: None
	Install Date: 4/1998	Installed Depth (ft): 78	Interpreted Movement Since Baseline (in): 0
		Interpreted Movement Monitoring Year (in): 0

Plot Type: Cumulative and Incremental		Plot Direction: A-Direction
Depth of Survey (ft): 78	Baseline Date: 5/3/2021	Corrections: None
Install Date: 4/1998	Installed Depth (ft): 78	Interpreted Movement Since Baseline (in): 0
		Interpreted Movement Monitoring Year (in): 0
