FY23/24 Maintenance and Monitoring

AD98-2, Calle del Barco

Yeh Project No.: 220-277

Subject: Annual Monitoring and Maintenance Report FY23/24, City of Malibu Assessment District 98-2, Calle del Barco, Malibu, CA

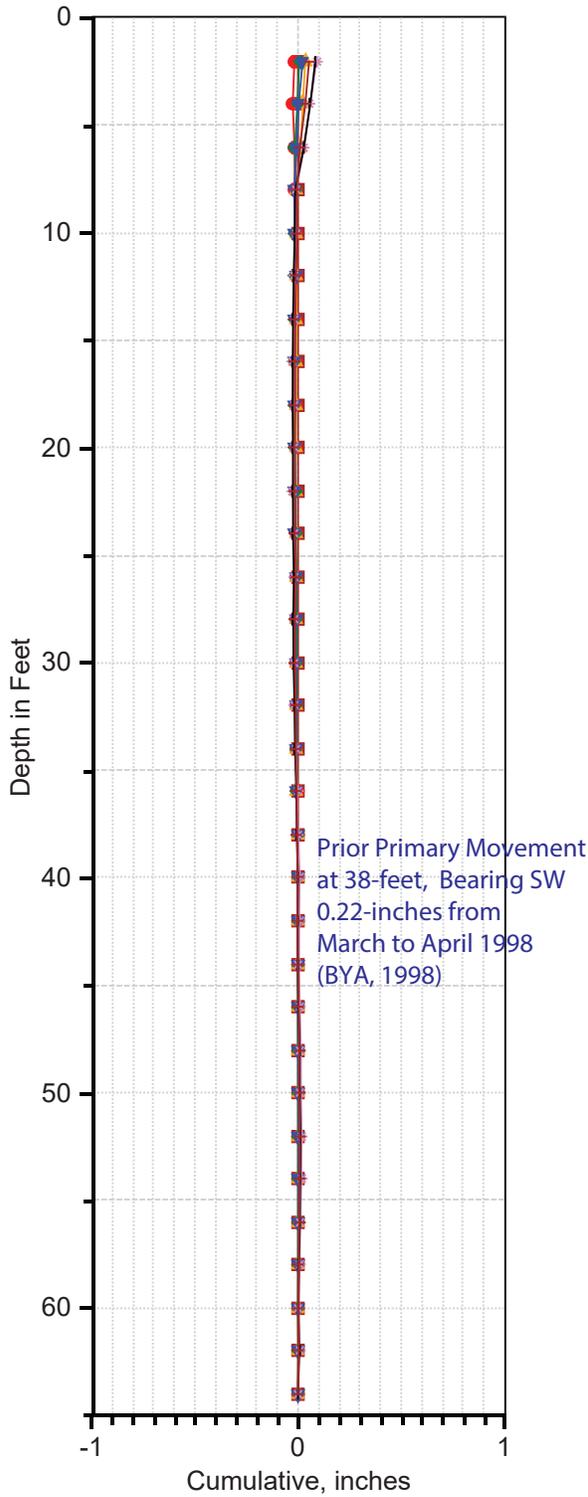
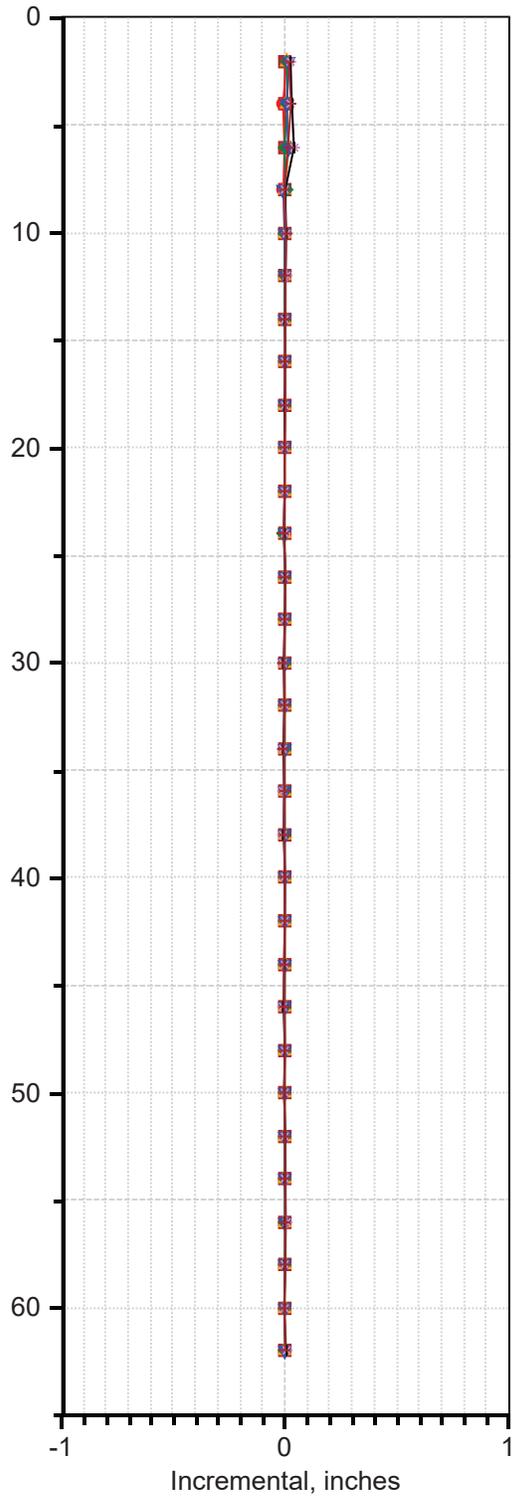
Casing deformation in SI-10 above approximately 12 feet is impeding smooth advancement of the traversing probe, which is potentially damaging to the probe sensors. The existing deformation at that depth may be the result of previous roadway construction in 1999 that involved replacement of the upper part of the casing. SI-10 will no longer be surveyed after August 23, 2023 and is earmarked for replacement.

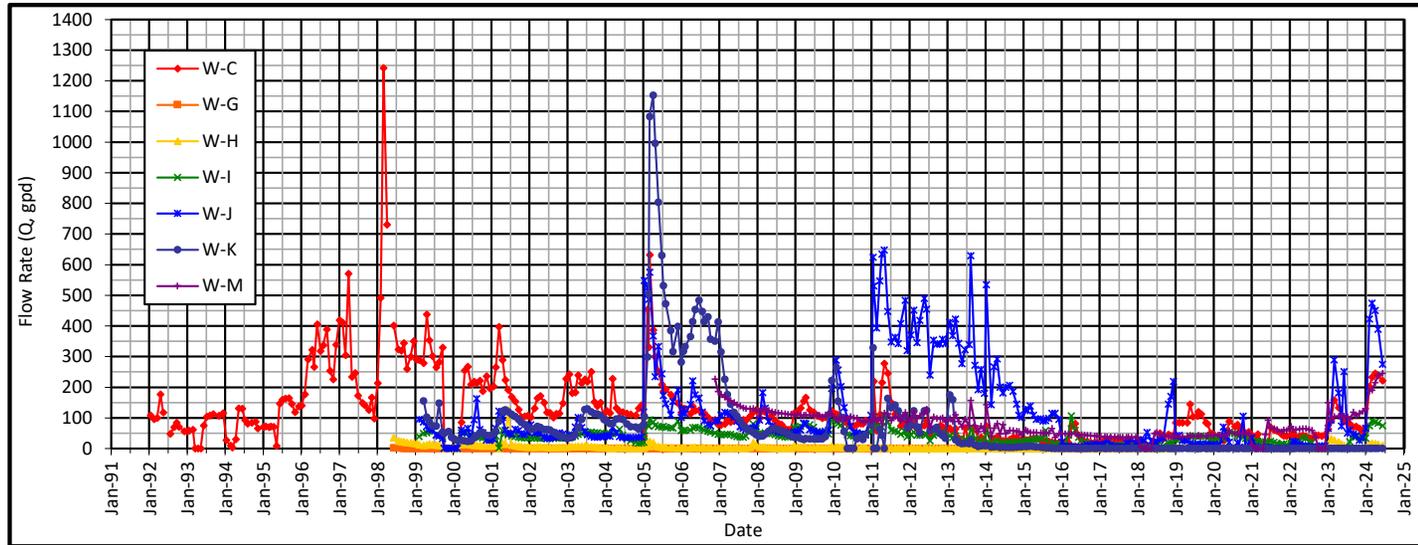
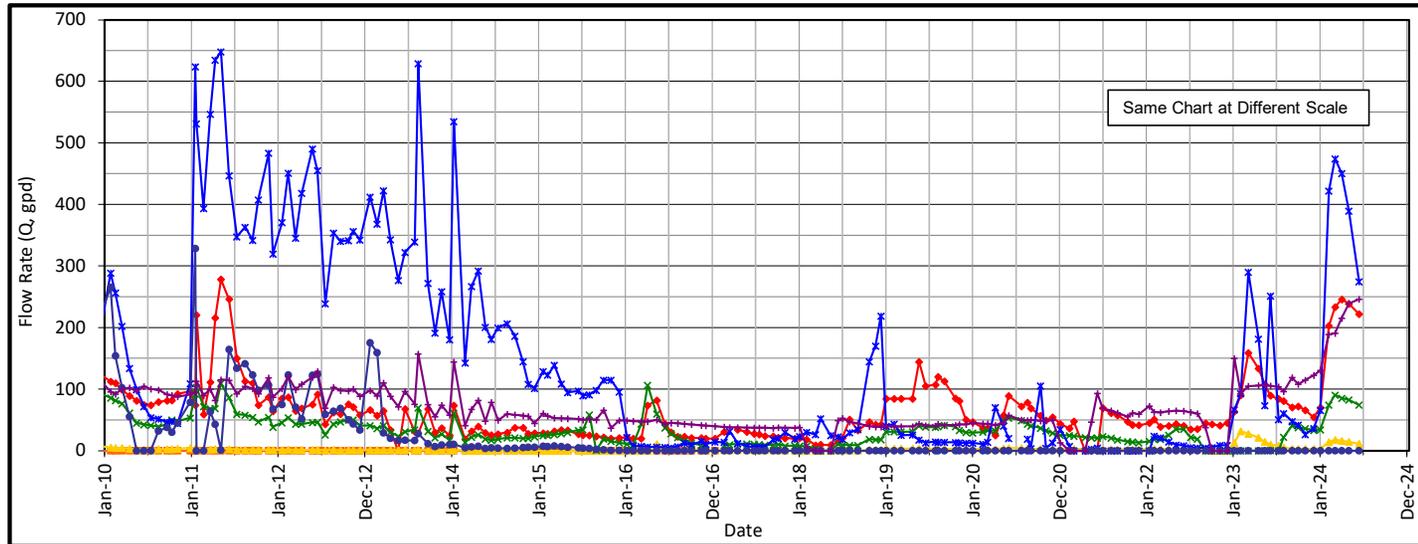
DEWATERING WELL DISCHARGE RATE GRAPH (MONITORING YEAR)

Well production typically varies in response to rainfall conditions. The dewatering well production increase over this monitoring year is consistent with the high rainfall totals.

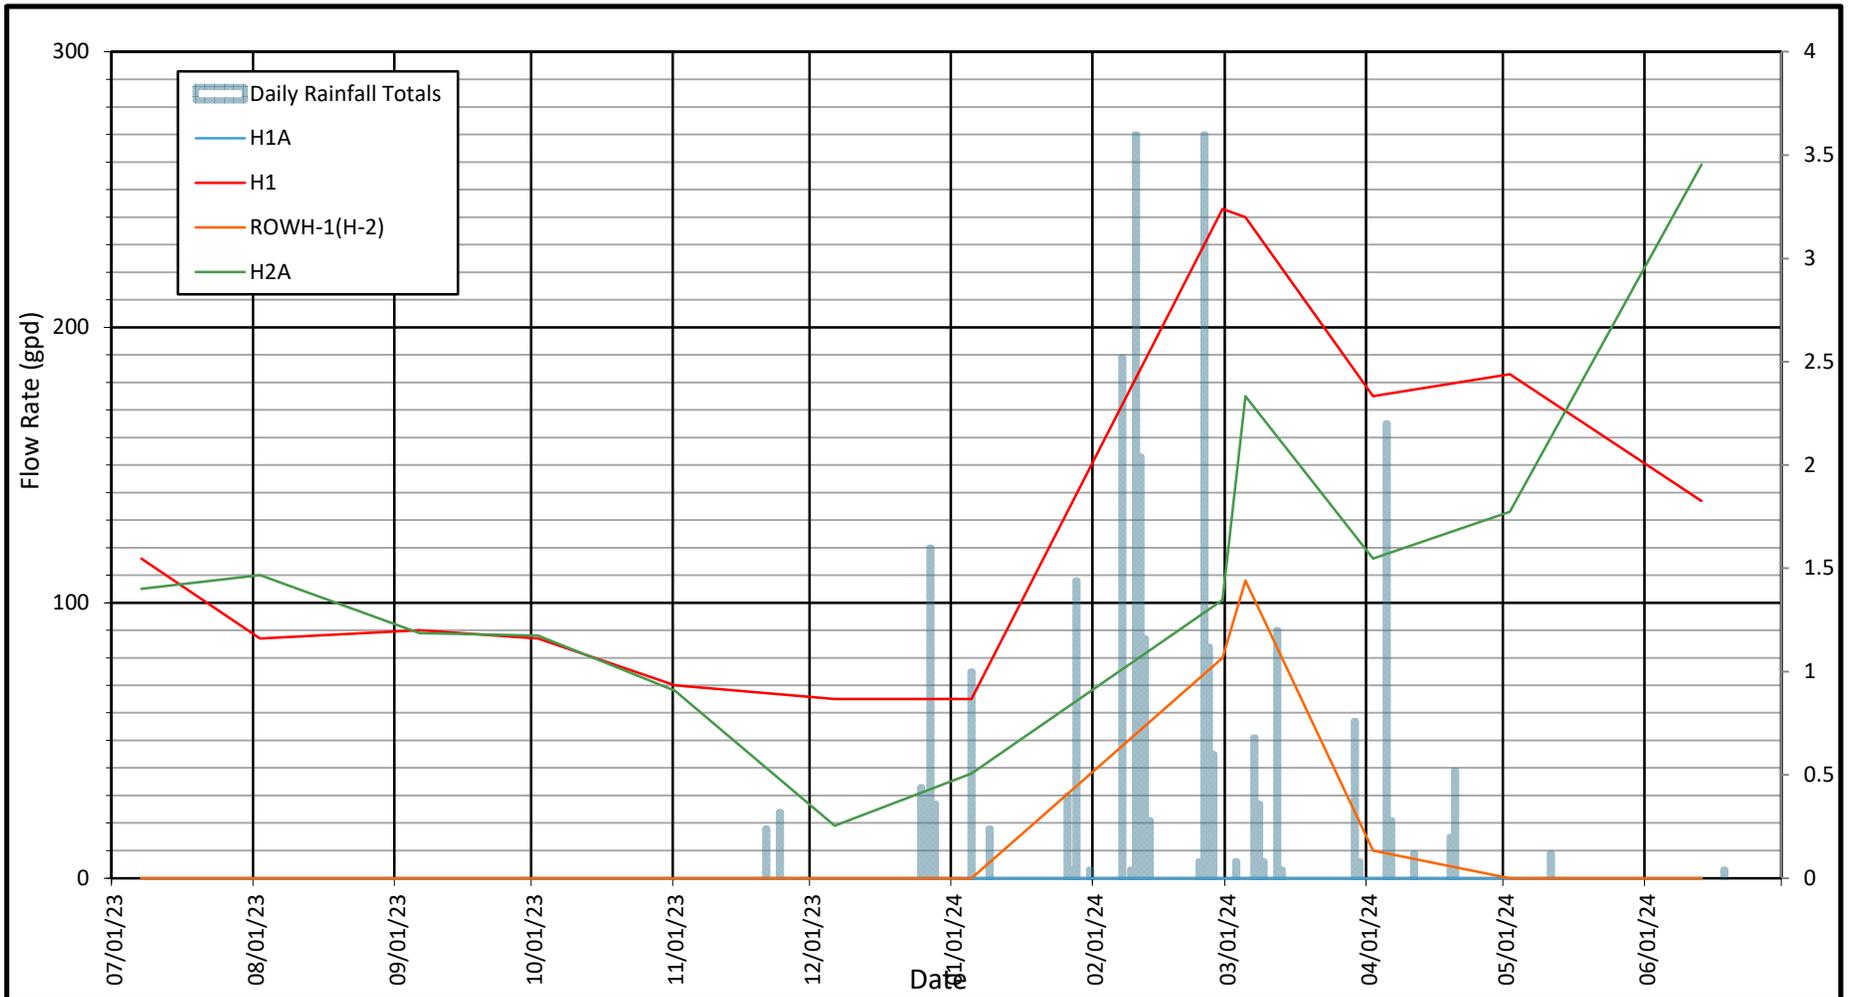
HYDRAUGER DISCHARGE RATE GRAPH (MONITORING YEAR)

Hydrauger production typically varies in response to rainfall conditions. The increase in average hydrauger production over this monitoring year from the previous monitoring year is primarily due to an increase in production at H-2A.
