Project No. 220-276

City of Malibu  
23825 Stuart Ranch Rd.  
Malibu, California 90265

**Subject: Interim Report of Dewatering System Status and Summary of Collected Data following Palisades Fire, City of Malibu Assessment District 98-1 - Big Rock Mesa, Malibu, CA**

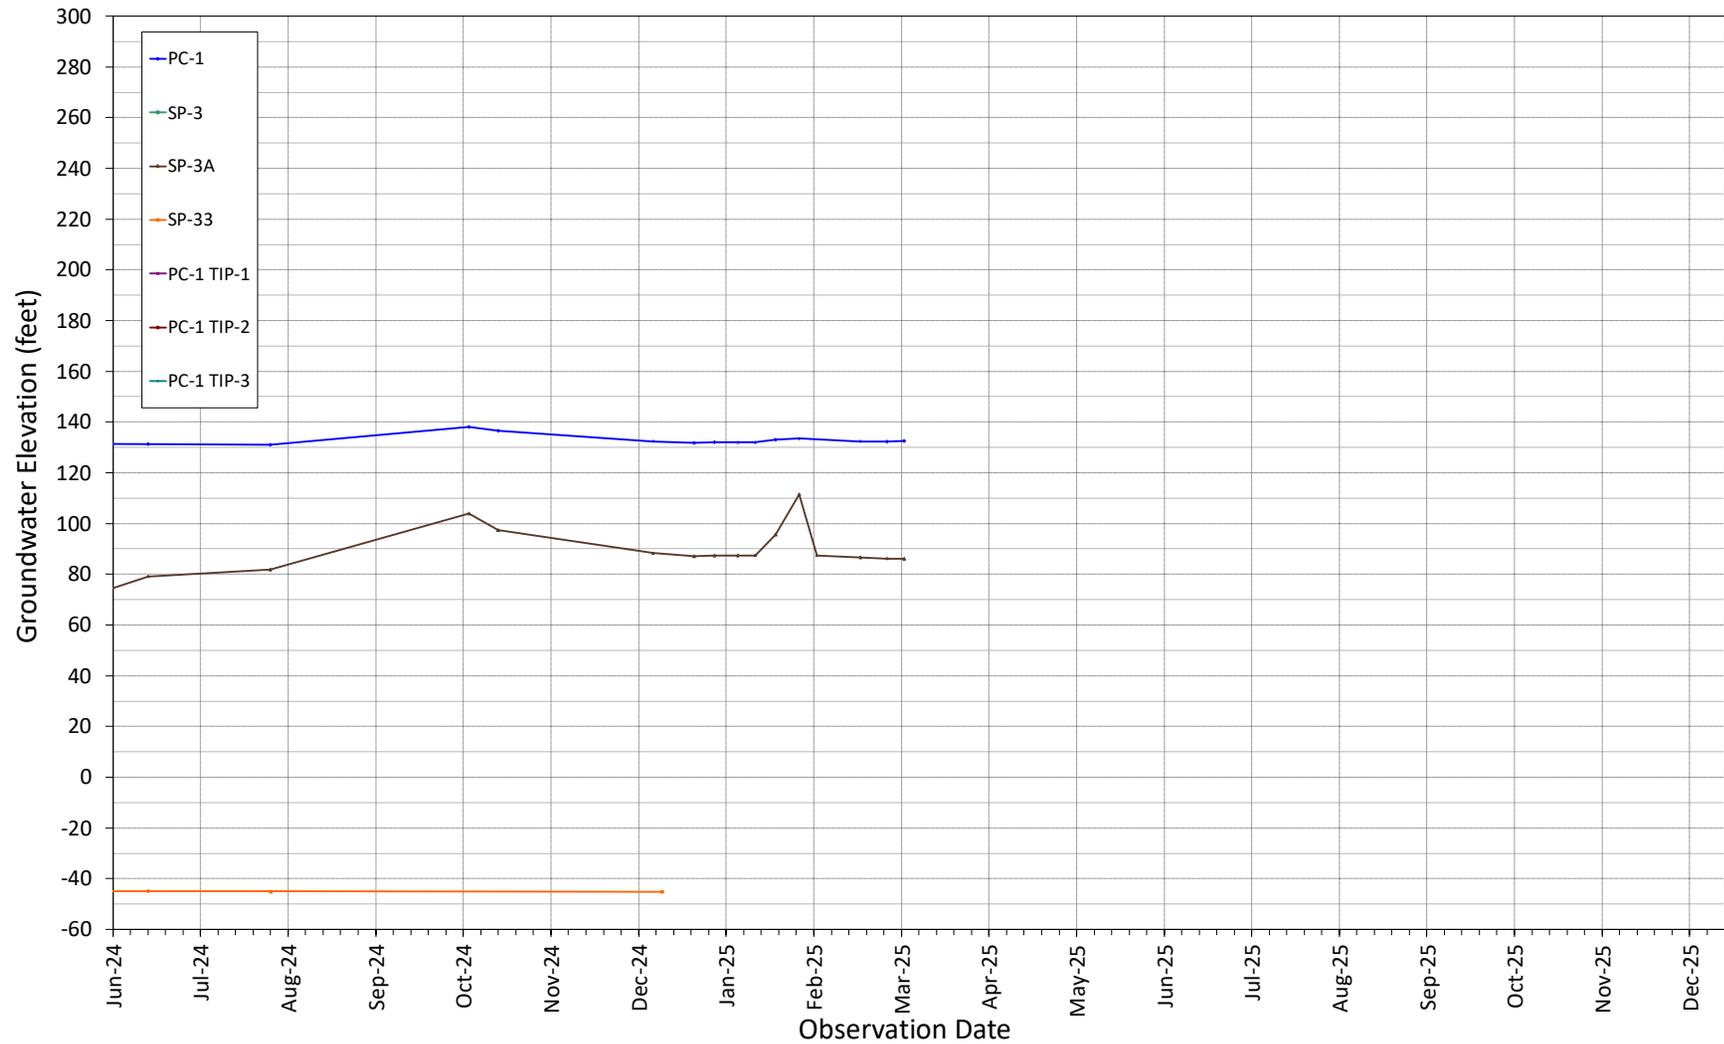
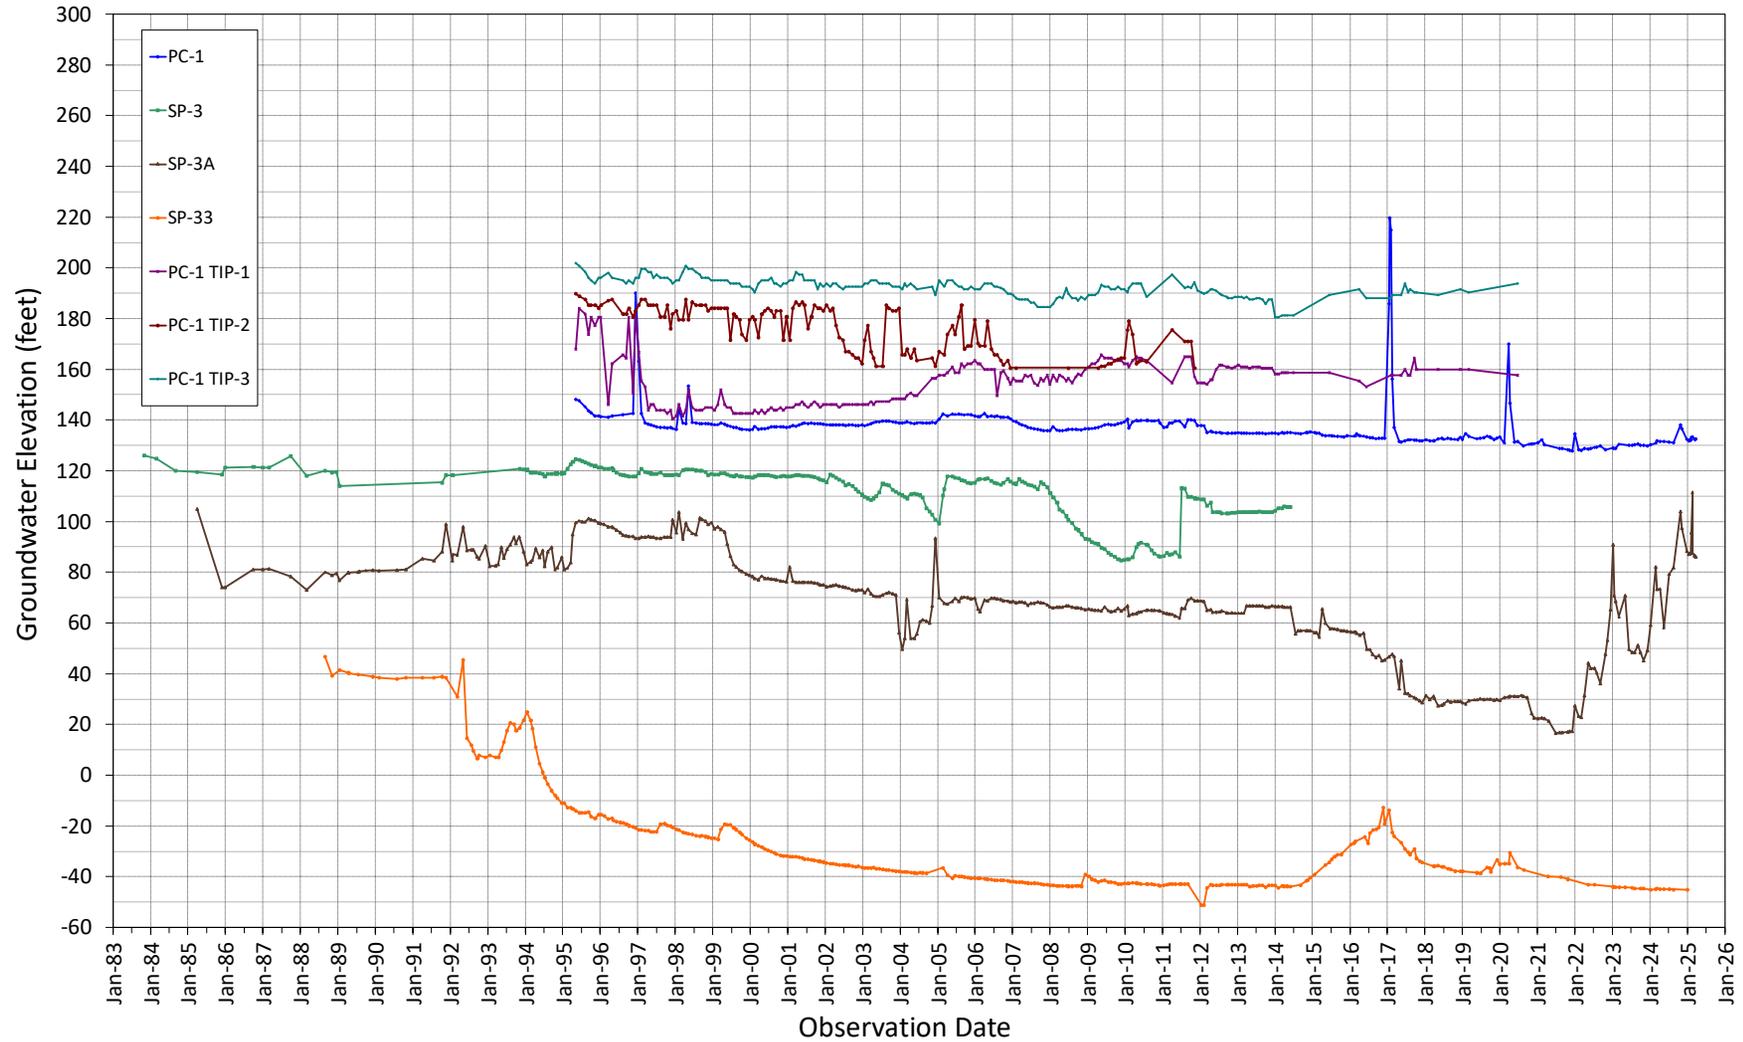
**GROUNDWATER HYDROGRAPH**  
**Eastern Mesa Region**  
Big Rock Mesa Landslide Assessment District  
Malibu, California

Water levels in the Eastern Region were monitored with standpipe monitoring wells SP-3, SP-3A and SP-33, piezometer PC-1 and de-powered dewatering well W-3 and summarized in Table 6. SP-3 was not monitored due to lack of property access and because it has been dry to its maximum (post-sheared off and filled in) depth since at least 2014. SP-33 was not monitored because it is located within private property of a damaged/destroyed residence.

Monthly groundwater levels in Standpipe SP-3A fluctuated in response to February rainfall and rose approximately 24.4-feet within the casing following February rain. This has been observed to be the result of surface runoff directly filling the casing during rainfall. Water levels in SP-3A relative to pre-fire December 2024 declined by 2.1-feet. Monthly water levels in PC-1 remained essentially unchanged with a slight increase of 0.1-feet. This elevation change is too small to infer causation resulting from decreased pumping versus normal seasonal fluctuations. Figure 3 presents plots of water elevation transducer data for PC-1 and SP-3A and W-3:
