**ANNUAL REPORT  
JULY 2010 THROUGH JUNE 2011  
CALLE DEL BARCO  
LANDSLIDE ASSESSMENT DISTRICT  
MALIBU, CALIFORNIA**

Prepared for:  
CITY OF MALIBU

November 2011  
Fugro Job No. 04.B3399005

Subject: Annual Report, July 2010 through June 2011, Calle del Barco Landslide Assessment District, Malibu, California

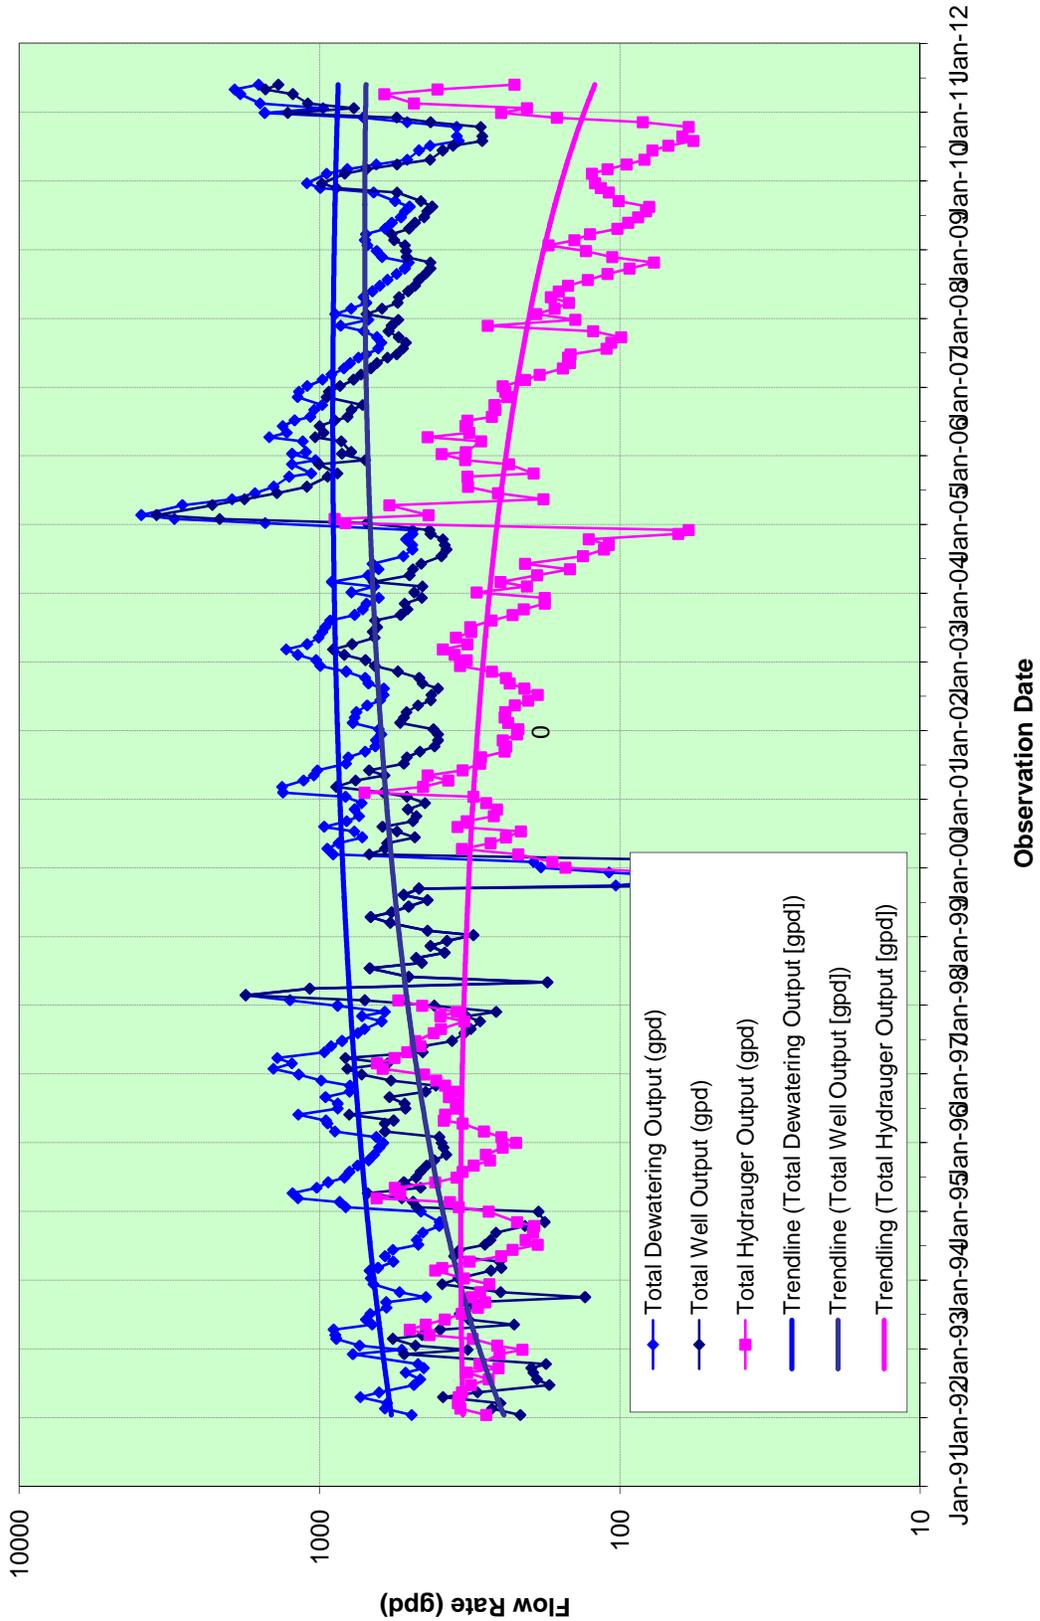
**DEWATERING GRAPH**  
Calle Del Barco  
(Total Output - All Wells & Hydaugers)

- Slope inclinometer readings indicate no significant ground movement.
- Additional dewatering facilities are recommended in order to increase the dewatering capacity of the landslide stabilization system. Plate 5 indicates decreased production from hydraugers. Over time, hydraugers become clogged and less efficient at removal of water by gravity. Replacement hydraugers should be considered for Rambla Orienta.
