**ANNUAL REPORT
JULY 2008 THROUGH JUNE 2009
CALLE DEL BARCO
LANDSLIDE ASSESSMENT DISTRICT
MALIBU, CALIFORNIA**

Prepared for:
CITY OF MALIBU

October 2009
Fugro Job No. 3399.005

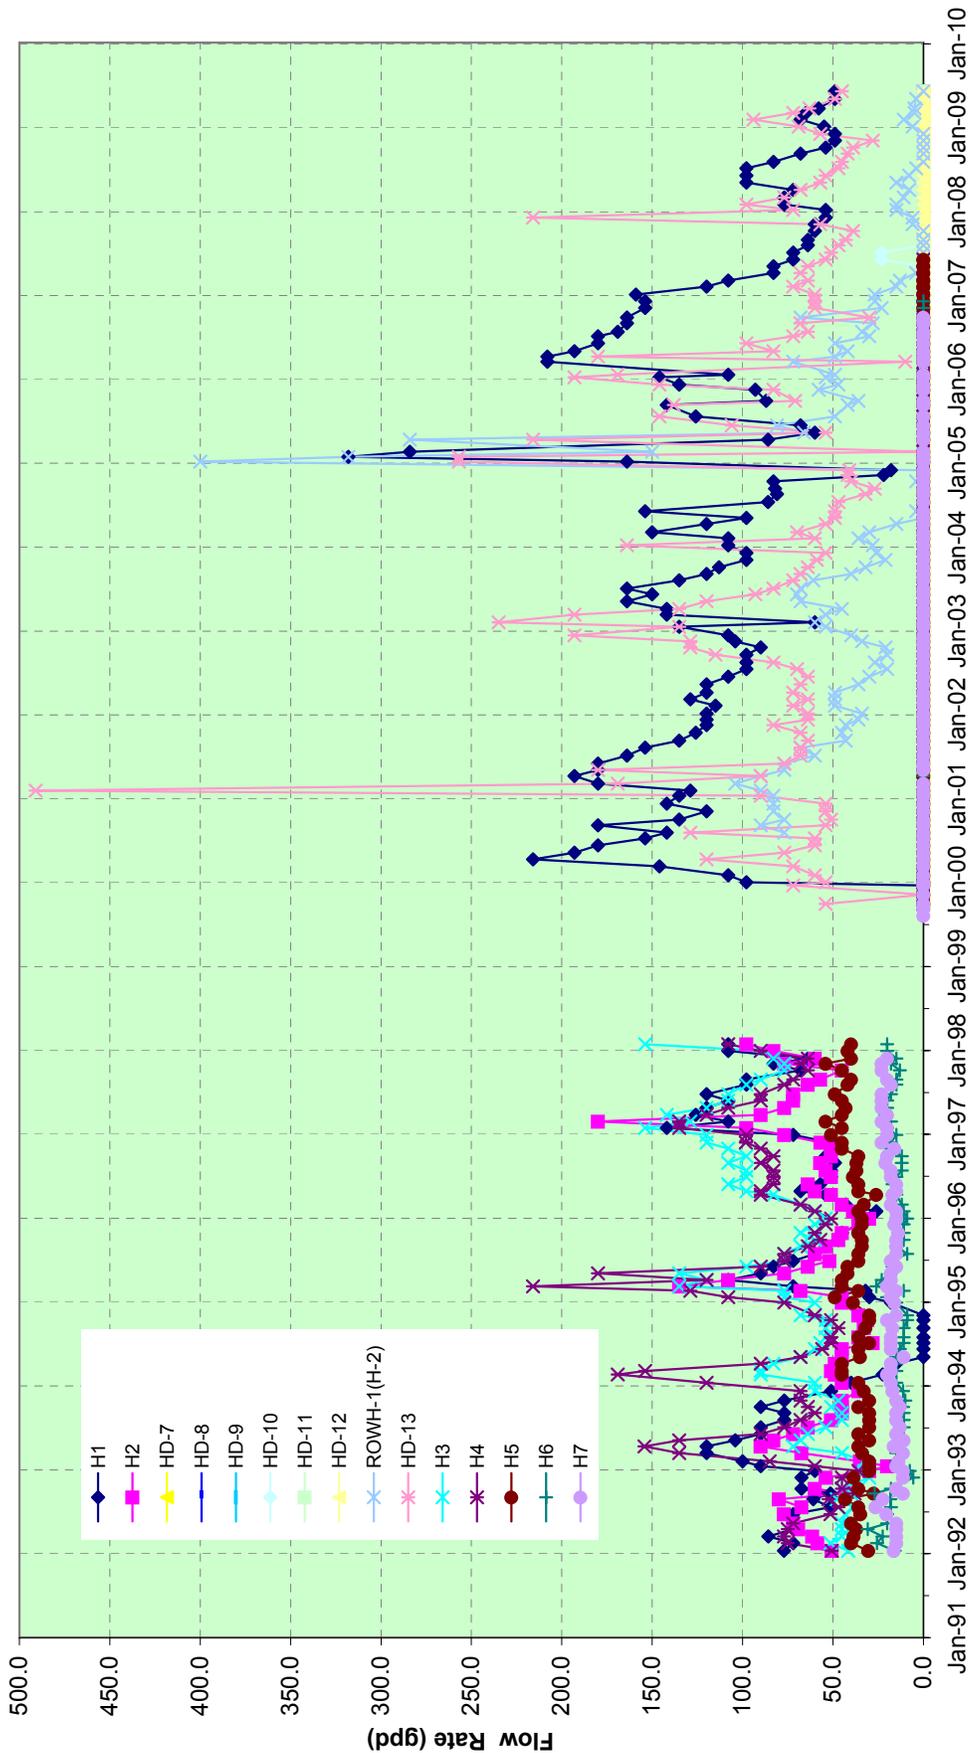
HYDRRAUGER GRAPH
2008 through 2009 Annual Report
Calle del Barco Landslide Assessment District
Malibu, California

- Additional dewatering facilities are recommended in order to increase the dewatering capacity of the landslide stabilization system. Plate 5 indicates decreased production from hydraugers. Over time, hydraugers become clogged and less efficient at removal of water by gravity. Replacement hydraugers should be considered for Rambla Orienta.
