Subject: CEQA Scoping Meeting, Proposed Septic Prohibition in the Malibu Civic Center Area (Public Notice No. 08-061) - Comments on Groundwater Basins in the Winter Canyon and Civic Center (Malibu Creek) Areas

Simplified Geologic Map
 Vicinity of Winter Canyon and Civic Center Area
 Malibu, California

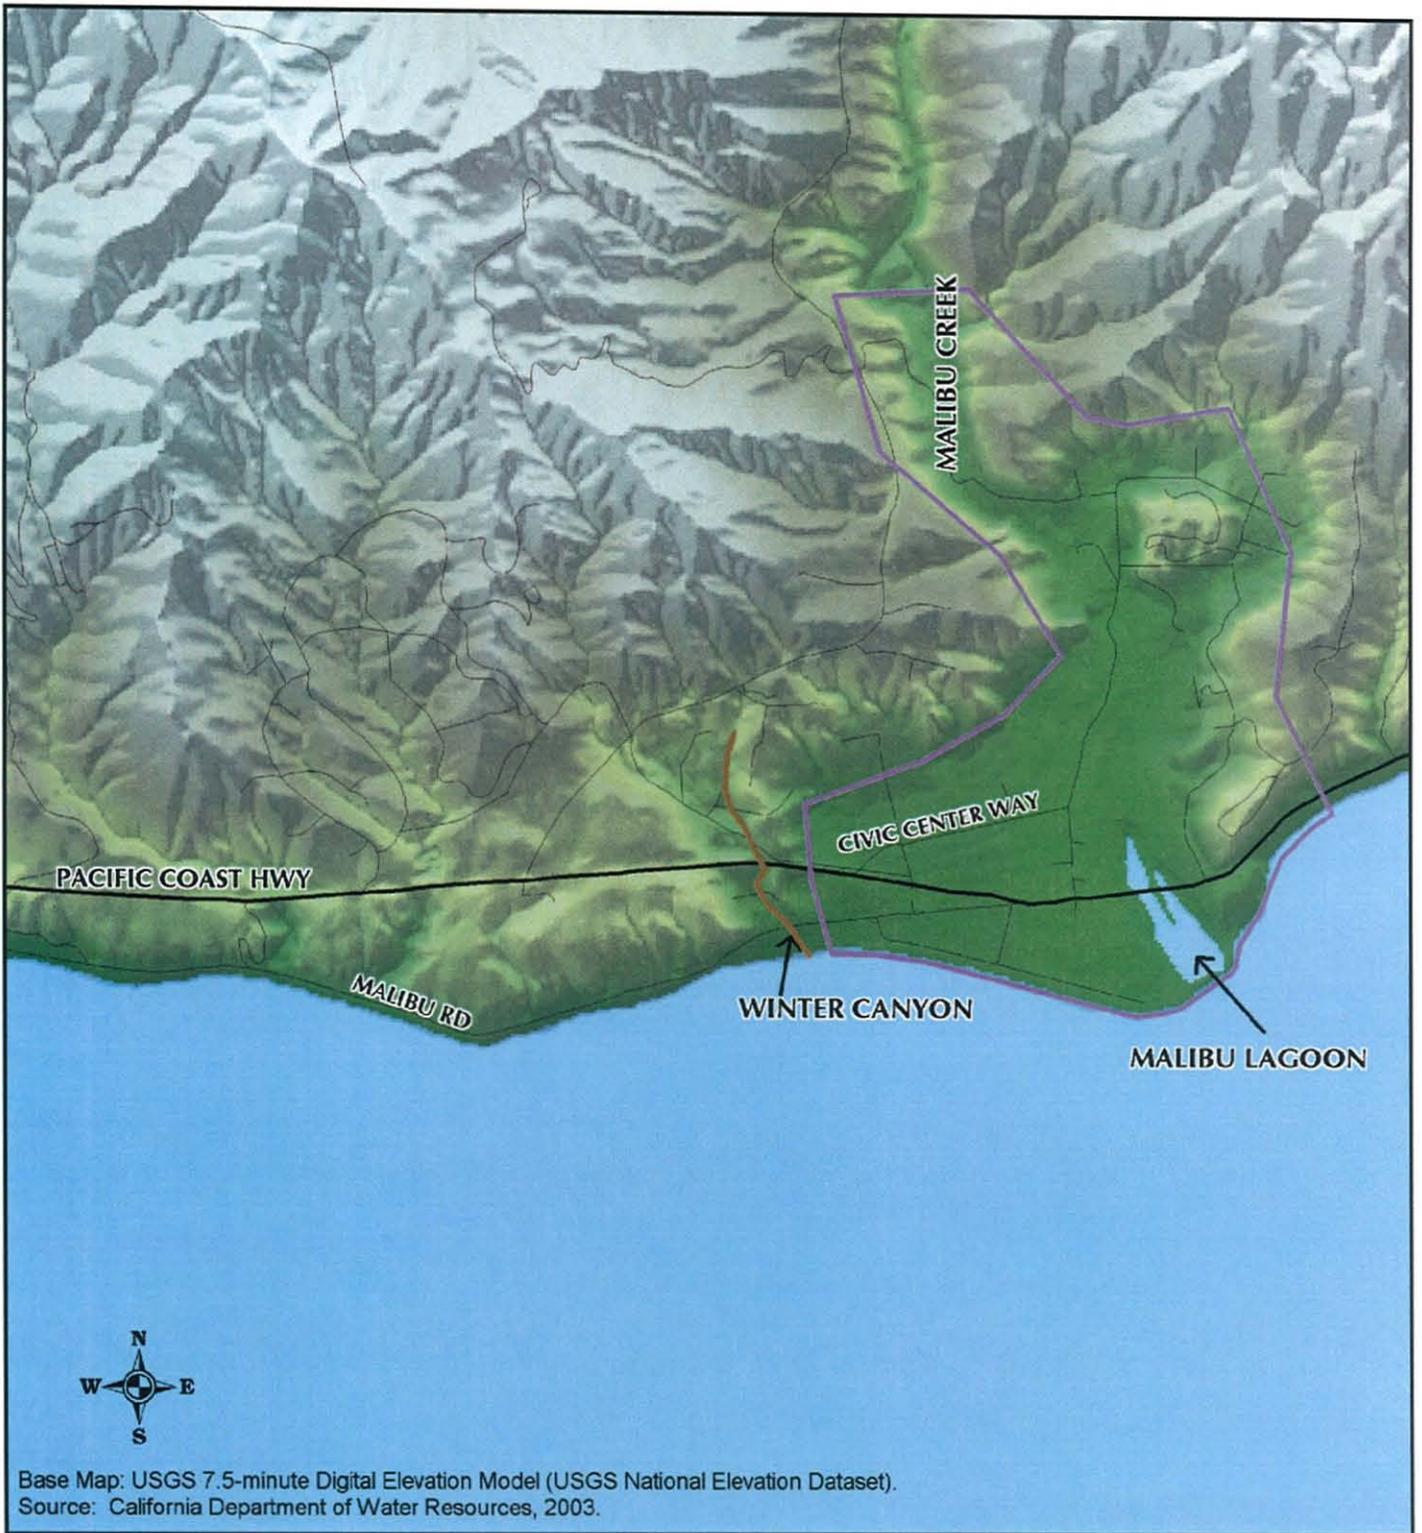
Figure 2

Malibu Valley Groundwater Basin
(DWR Basin Number 4-22)
 Malibu, California

The DWR boundaries of the Malibu Valley Groundwater Basin, shown on Figure 2, do not include Winter Canyon.

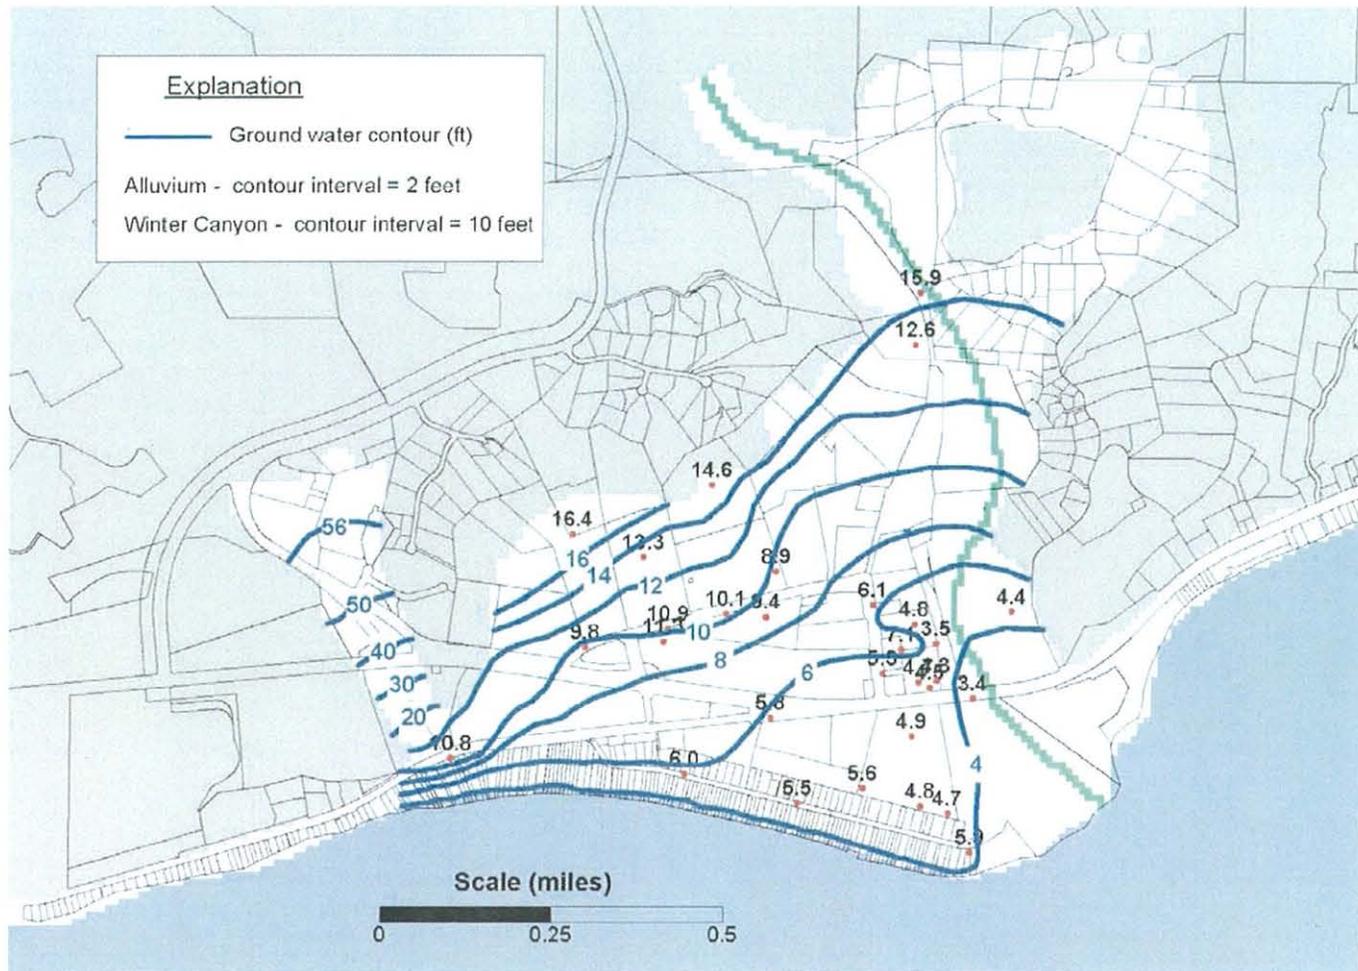
Source: Stone Environmental, 2004

The lack of hydraulic connectivity between Winter Canyon and the Civic Center area is further illustrated in Figures 3 and 4, reproduced from Stone Environmental, Inc. (2004). Water levels measured during September 2003 (unbreached lagoon) and during March 2004 (breached lagoon) show:

- The two areas are very different with respect to water level and flow gradient.
- Neither system flows into the other – the only location where mixing of the waters might occur is south of Malibu Road, at the ocean/groundwater interface.
- Although flow patterns in the Malibu Creek/Civic Center area are altered significantly by changes in the lagoon's exposure to the ocean, Winter Canyon's water levels are not affected.

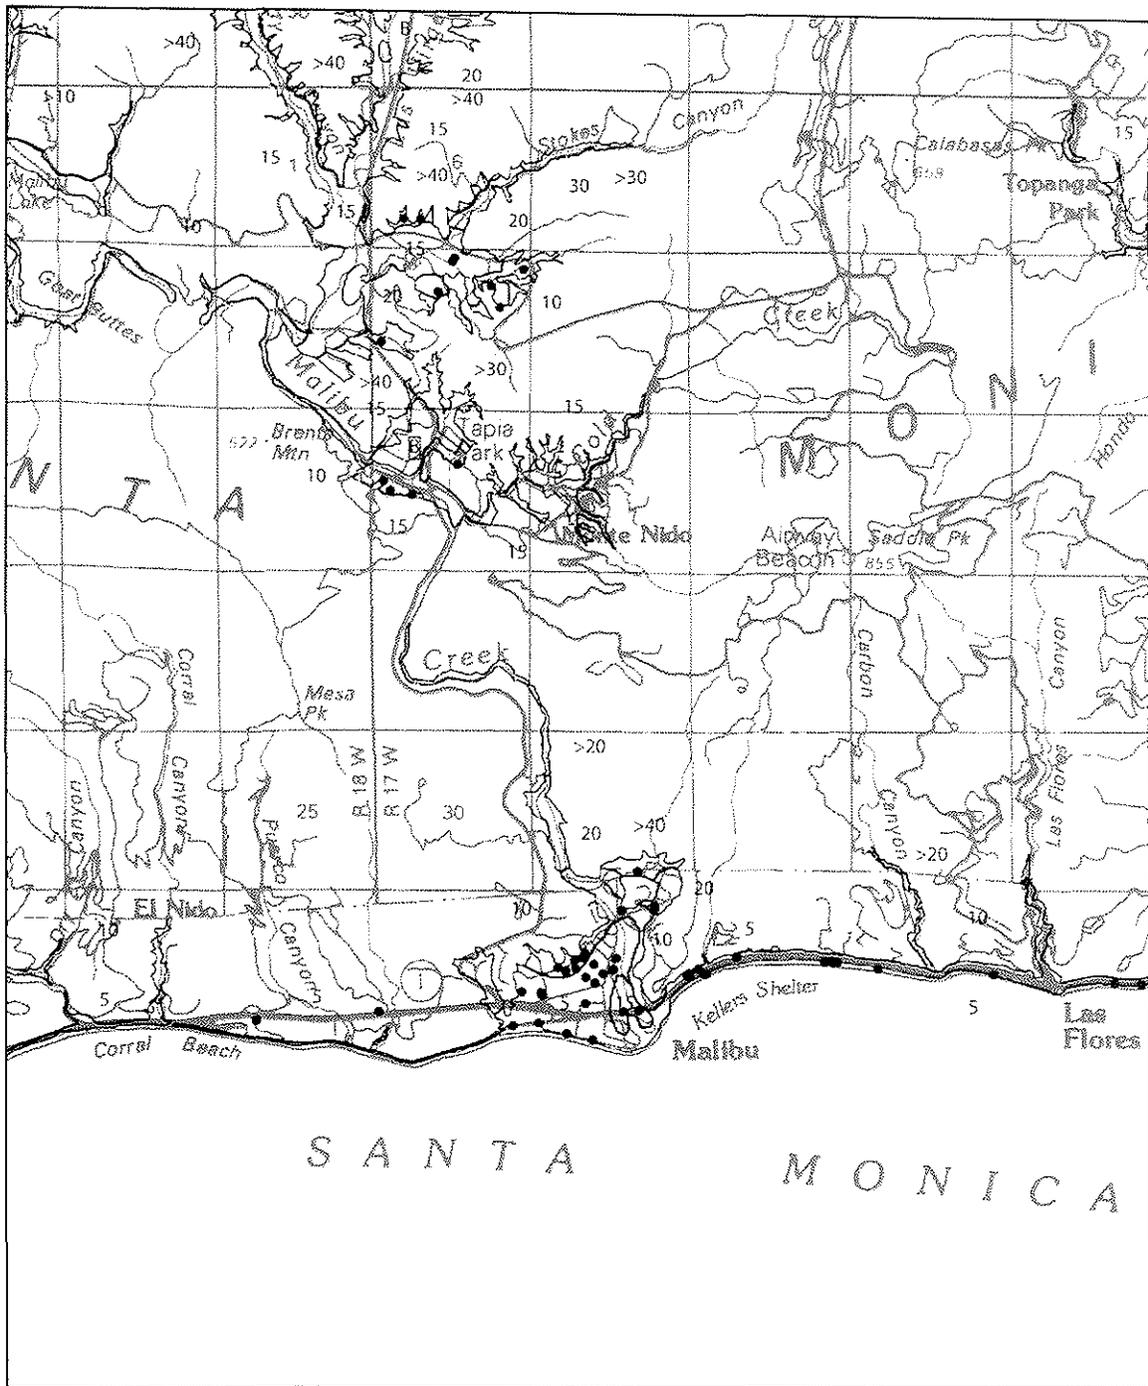
Plate 1.2 Depth to historically high ground water and borehole locations, Malibu Beach 7.5-minute Quadrangle, California.

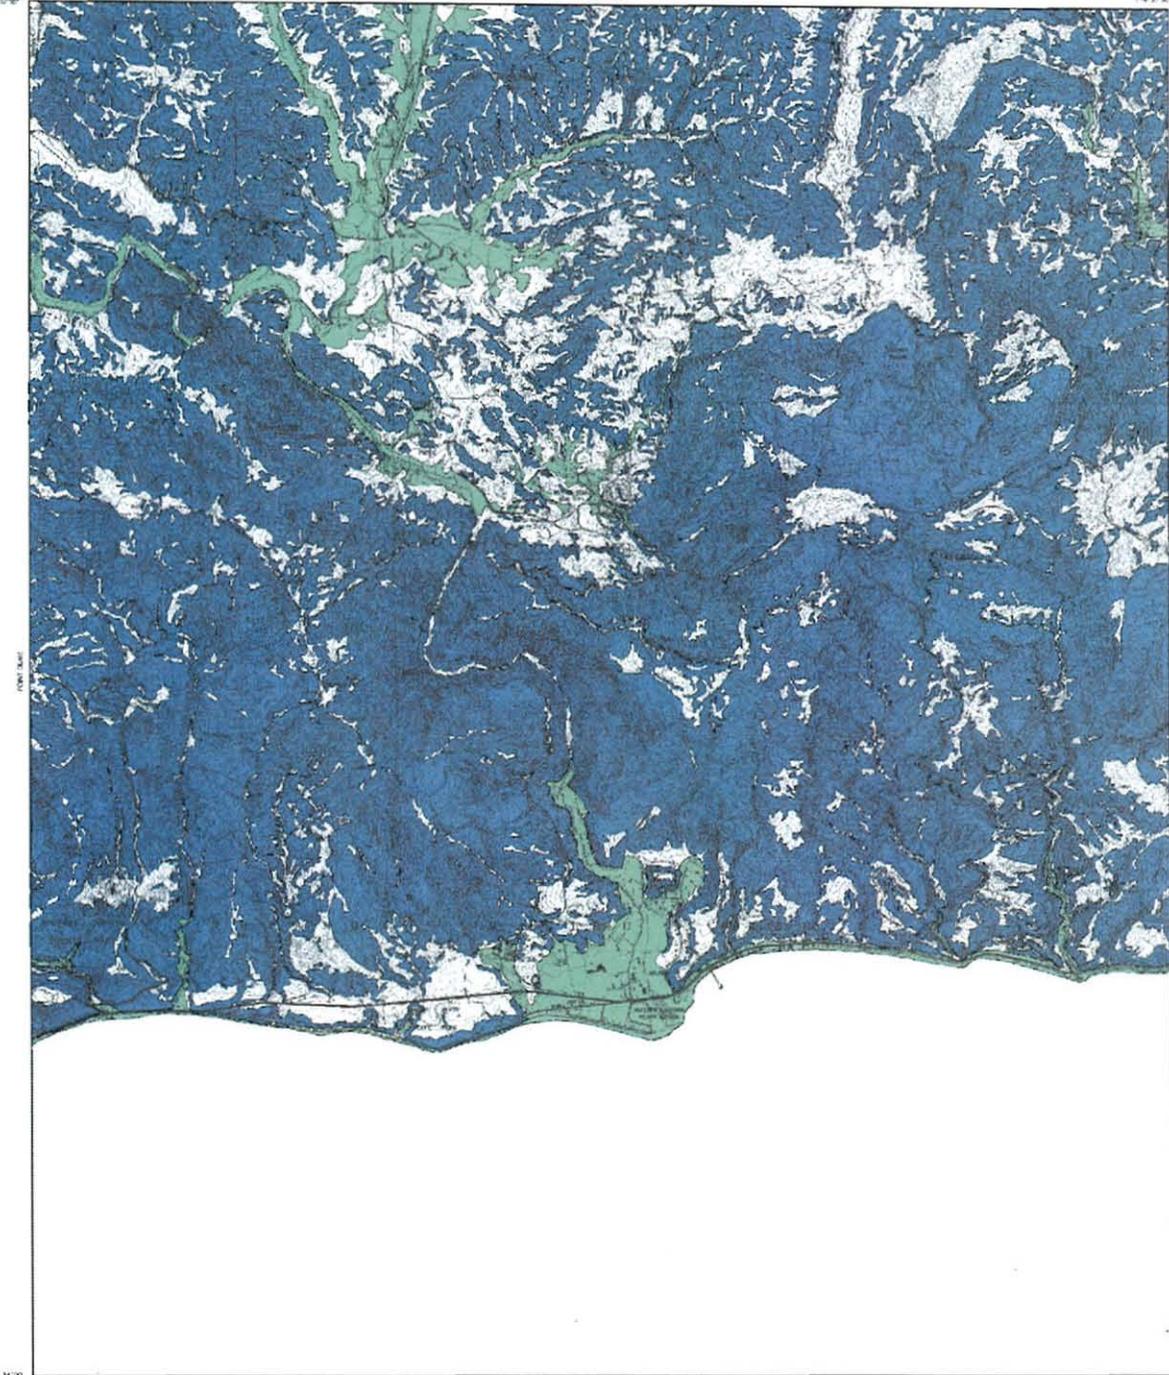
**STATE OF CALIFORNIA
 SEISMIC HAZARD ZONES**

- Zones of Required Investigation**
- Liquefaction**
 Areas where historic occurrence of liquefaction, or local geologic, geotechnical, and/or geotechnical conditions indicate a potential for permanent ground displacements such that mitigation is defined as Public Resources Code Section 26002 (a) is required.
 - Permissible Induced Landslides**
 Areas where previous occurrence of landslides, or local geologic, geotechnical, and/or geotechnical conditions indicate a potential for permanent ground displacements such that mitigation is defined as Public Resources Code Section 26002 (a) is required.
